Technical Report REMR-CS-41 October 1993

Comparison of Cast-in-Place Concrete Versus Precast Concrete Stay-in-Place Forming Systems for Lock Wall Rehabilitation

by William R. Miles
Donald J. Bergmann & Associates, P.C.

Prepared for U.S. Army Corps of Engineers

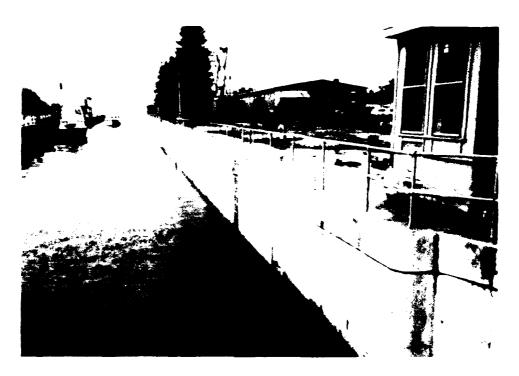
Figure 22. Rehabed lock chamber returned to operation

The appearance of precast panels in the lock chamber (see Figures 22 and 23) and on the river wall (see Figures 24 and 25) is very smooth and uniform. The limited cracking noted above is only visible at the locations repaired using the sealer material due to a difference in coloration from the concrete. Some seepage, especially in the west chamber wall, is noticeable at open vertical joints and at small openings in the horizontal joints.

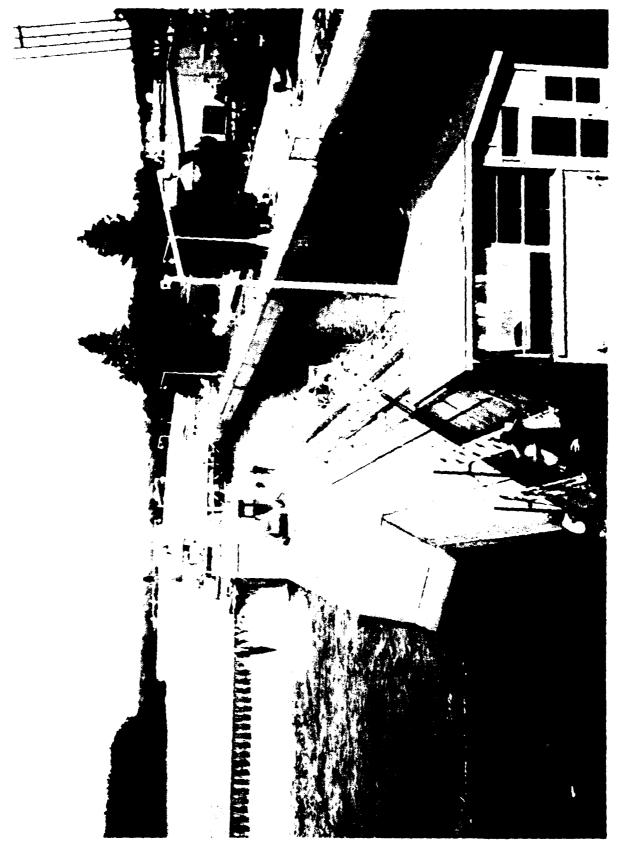
Figure 27. Troy Lock and Dam, Rehabilitation almost complete

The finish appearance of the precast panels is excellent (see Figure 27). They are very smooth, uniform in color and neatly aligned. Their smooth surface provides for less accumulation of sediments and algae resulting in cleaner appearance. The cast-in-place concrete wall surfaces, on the other hand, with their extensive cracking, seepage lines, rougher texture, and less uniform coloring have a more deteriorated appearance.
